111 E. North Avenue, Bartlett, IL 60103

BUILDING SUMMARY			
Gross SF	60,466	Number of Levels	1
Year Built	1928	Number of Additions	6

AGGREGATED FACILITY GRADE

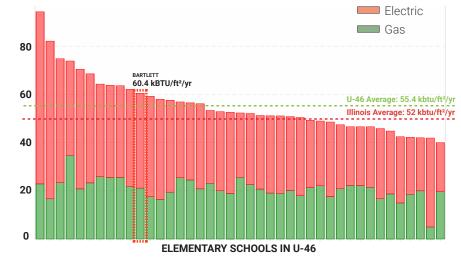
Energy Usage(10%)		
Total EUI	60.4kBTU/SF/yr	
Electric	21.1kBTU/SF/yr	
Gas	39.3kBTU/SF/yr

Energy Use Intensity (EUI) is a key metric that expresses a building's energy use as a function of its size. Generally, a low EUI signifies good energy performance

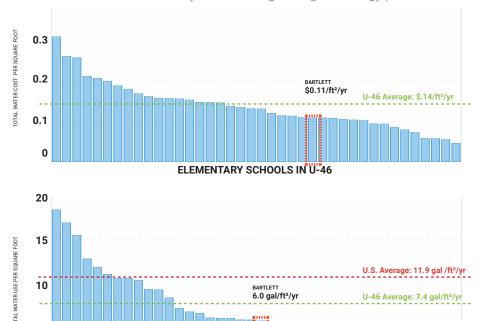
ELEMENTARY SCHOOLS IN U-46 Water usage is a key metric that expresses a school's water use and total cost of water in comparison to the other elementary schools in the district.
