January 27, 2021

Phase 1 Snapshot ■ DLR Group

Highland Elementary School

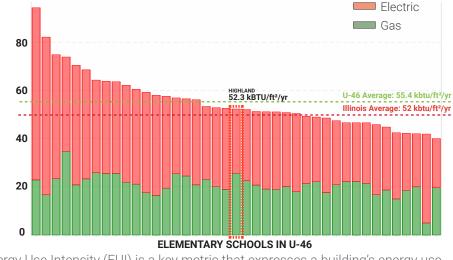
Energy Use Intensity (EUI) is a key metric that expresses a building's energy use as a function of its size. Generally, a low EUI signifies good energy performance

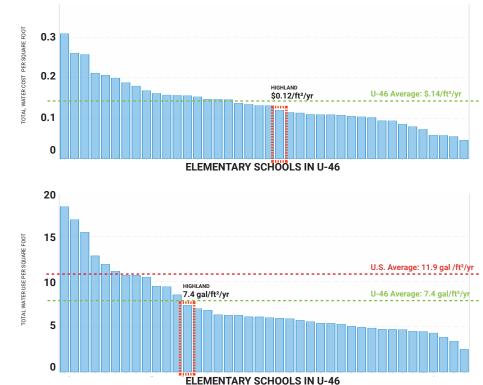
Water usage is a key metric that expresses a school's water use and total cost of water in comparison to the other elementary schools in the district.
