716 Sunnydale Blvd, Streamwood, IL 60107

BUILDING SUMMARY			
Gross SF	47,435	Number of Levels	1
Year Built	1967	Number of Additions	2

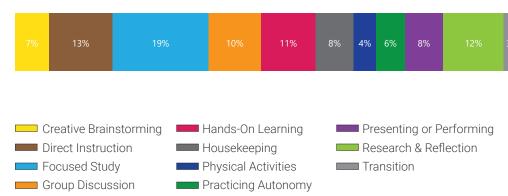
Activity mapping is based on survey data (Week in the Life) collected by teachers throughout the district over the course of one week. The teachers provided the learning activity and amount of time spent in that activity. Data was aggregated for the school and is represented by the average percent of time spent in the activity.

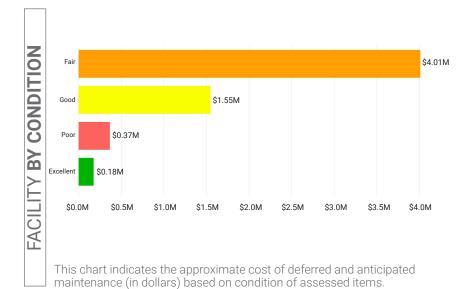
This chart indicates the approximate cost of deferred and anticipated maintenance (in dollars) of items assessed by building system. Highlighted items indicate those items in immediate need, code requirement, poor and fair condition.

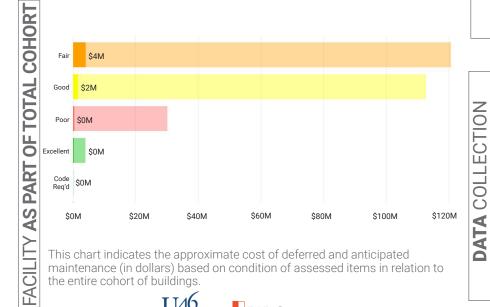
This chart indicates the approximate cost of deferred and anticipated maintenance (in dollars) based on condition of assessed items in relation to the entire cohort of buildings.

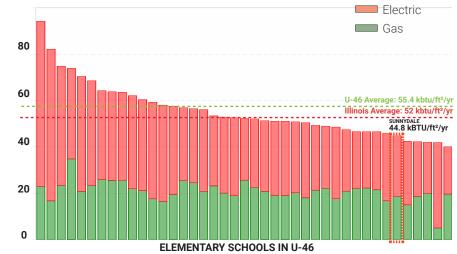
Energy Use Intensity (EUI) is a key metric that expresses a building's energy use as a function of its size. Generally, a low EUI signifies good energy performance

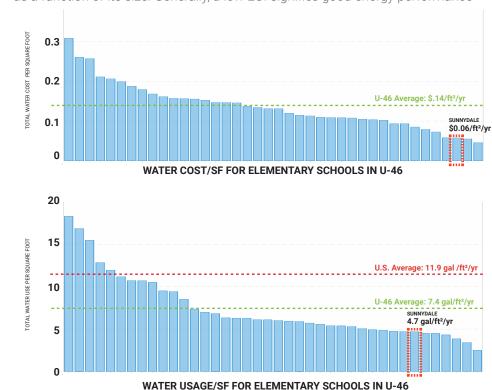
Water usage is a key metric that expresses a school's water use and total cost of water in comparison to the other middle schools in the district.
