Timber Trails Elementary School

1675 McDonough Road, Hoffman Estates, IL 60192

| BUILDING SUMMARY | | | |

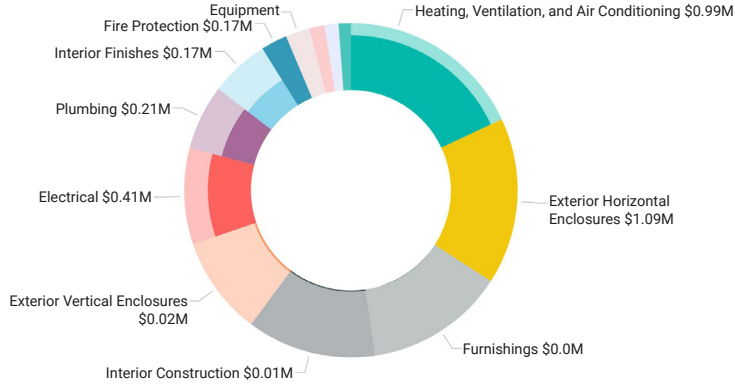
This chart indicates the approximate cost of deferred and anticipated maintenance (in dollars) of items assessed by building system. Highlighted items indicate those items in immediate need, code requirement, poor and fair condition.

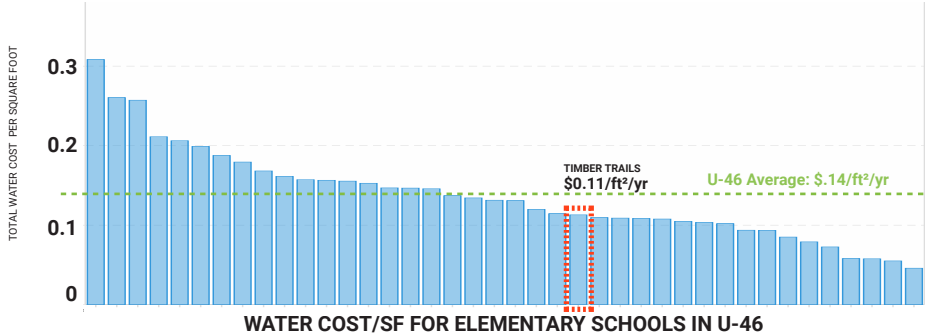
Water usage is a key metric that expresses a school's water use and total cost of water in comparison to the other middle schools in the district.
