DLR Group

Phase 1 Snapshot

# AGGREGATED FACILITY GRADE

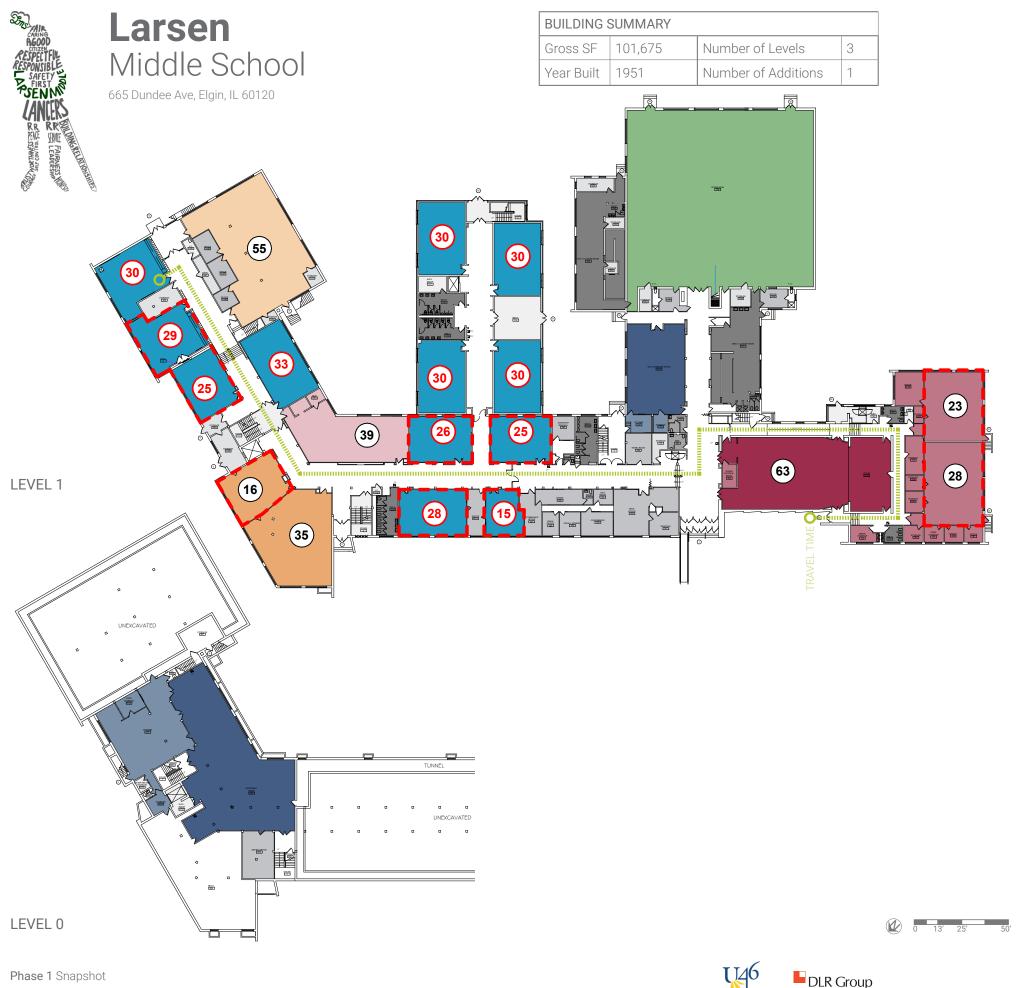
**4–6** Furthest approximate travel time from one location to another for an average Middle School Student.

TRAVEL

OmO Travel Path Room Capacity 10 based on ISBE Guidelines Room Capacity 10 based on ISBE Guidelines (not included in Effective

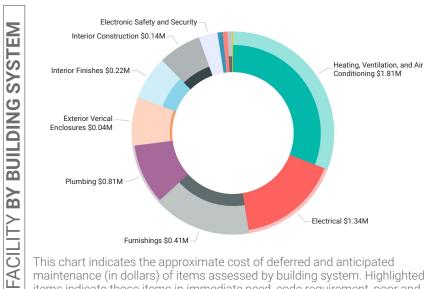
This chart indicates the approximate cost of deferred and anticipated maintenance (in dollars) of items assessed by building system. Highlighted items indicate those items in immediate need, code requirement, poor and fair condition.

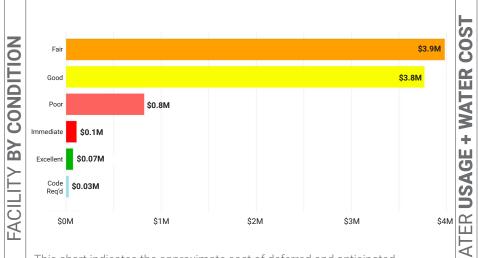
This chart indicates the approximate cost of deferred and anticipated maintenance (in dollars) based on condition of assessed items.

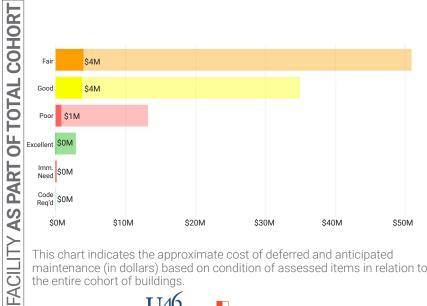
maintenance (in dollars) based on condition of assessed items in relation to the entire cohort of buildings.

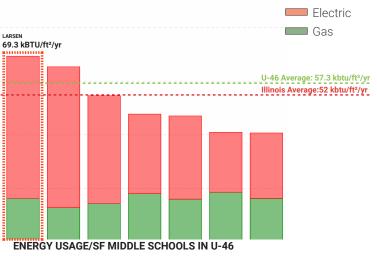
Energy Use Intensity (EUI) is a key metric that expresses a building's energy use as a function of its size. Generally, a low EUI signifies good energy performance

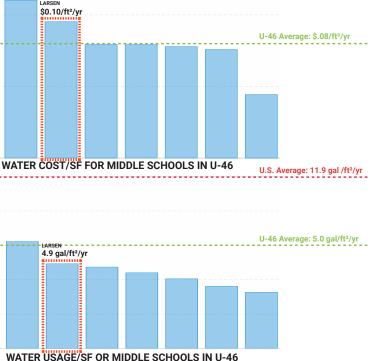
Water usage is a key metric that expresses a school's water use and total cost of water in comparison to the other middle schools in the district.
